**Visy Industries Australia Pty Ltd**

**INDEPENDENT ENVIRONMENTAL AUDIT**

**112-120 Euston Road, Alexandria, NSW**

**22 December 2022**

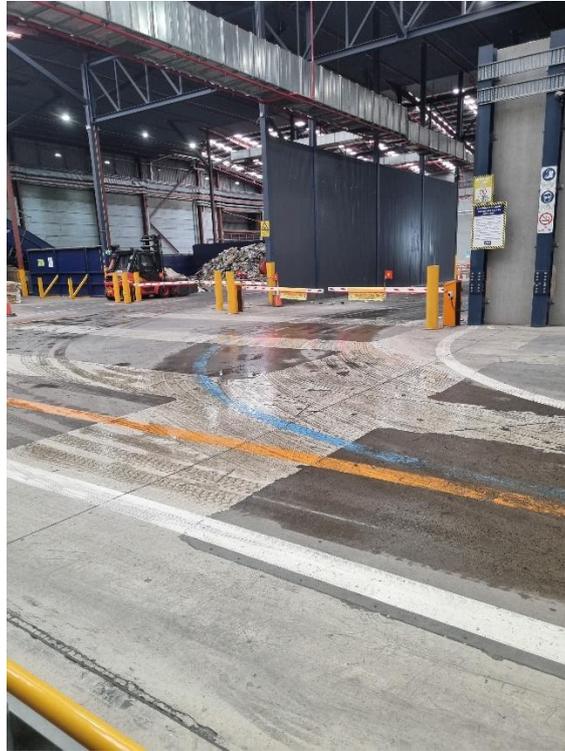
Operational controls have been designed and implemented to minimize dust emissions. Dust is contained with the operations building and is extracted and discharged via a point source (stacks through the roof). Fugitive emissions are minimized using fast acting soft doors at the entry and exit for trucks to the warehouse building. No obvious signs of excessive dust or litter either within or near the Site were observed during the Site inspection (see photo 1 and 2).

**Photo ID:** 1 – Paper/cardboard receival bay (on the left)

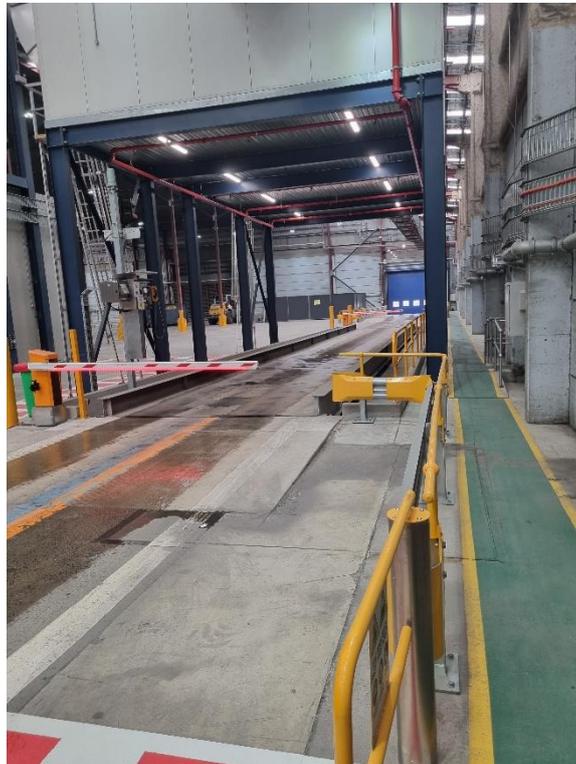
**Photo ID:** 2 - Entry, inbound weighbridge and staging area

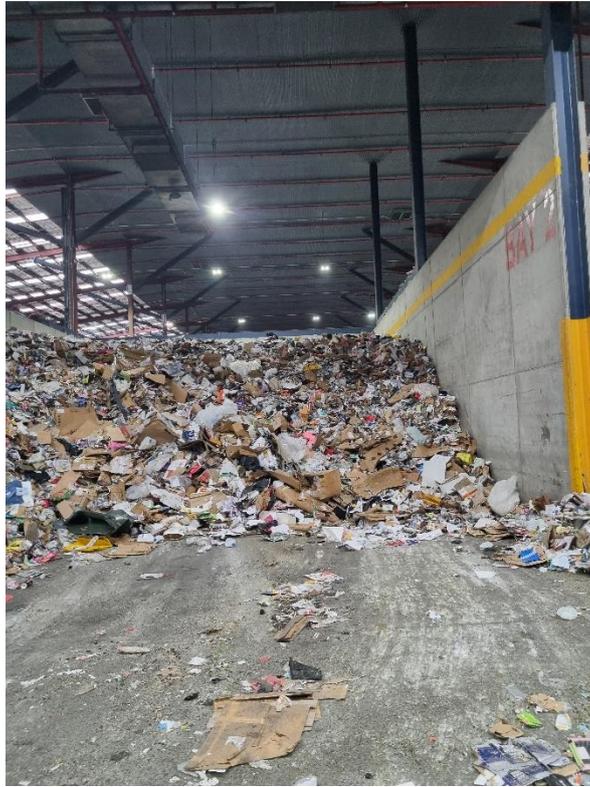
Continuous monitoring via a waste tracking software is undertaken to ensure FCM stockpile and bale stack height do not exceed 5 m in height (measured by a yellow marker line drawn on the wall of the receival bays) and 250 tonnes in each receival bay in accordance with the requirements of the EPL. The FCM in the bunds were not observed to exceed the 5 m marker during the Site Inspection (see photo 3).

**Photo ID:** 3 - FCM receival bay

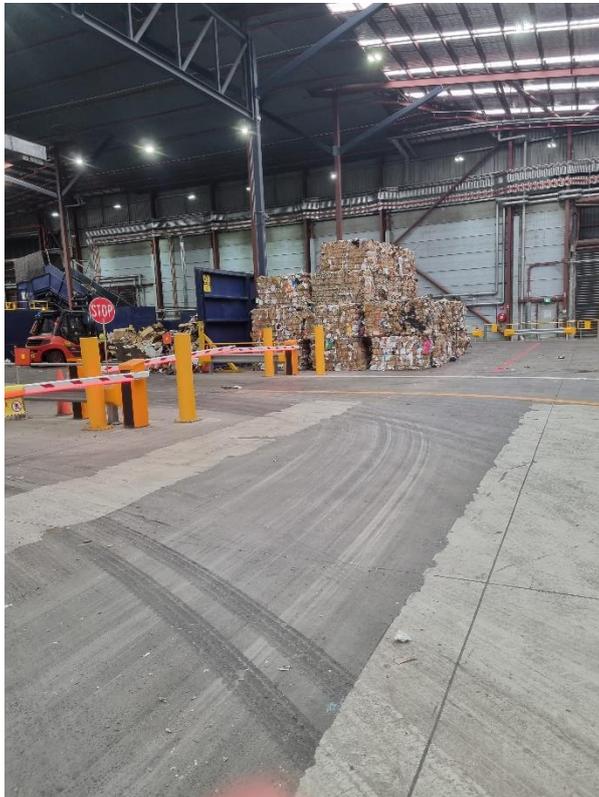
**Photo ID:** 4 - Paper/cardboard bale storage

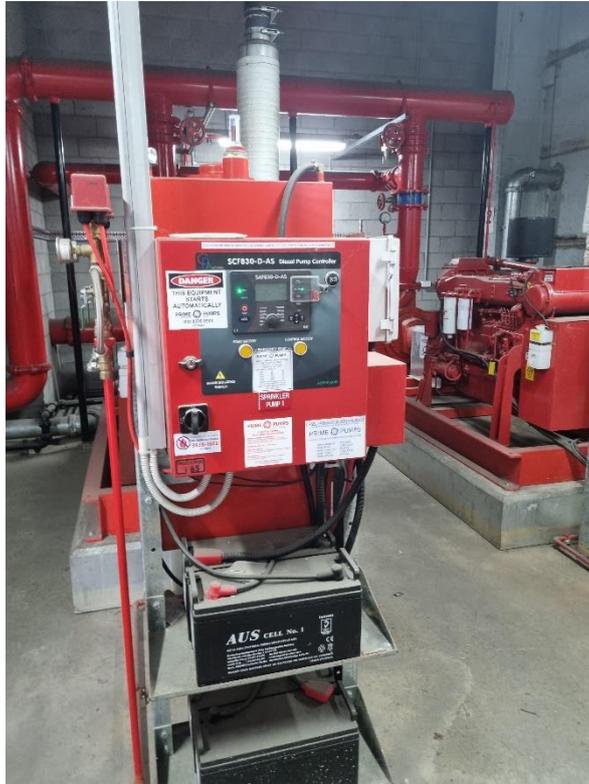
Fire safety checks are conducted by an external contractor, records of the checks were available on site and no equipment was observed to be out-of-date during the Site inspection.

**Photo ID:** 5 - Fire services system inside fire pump room

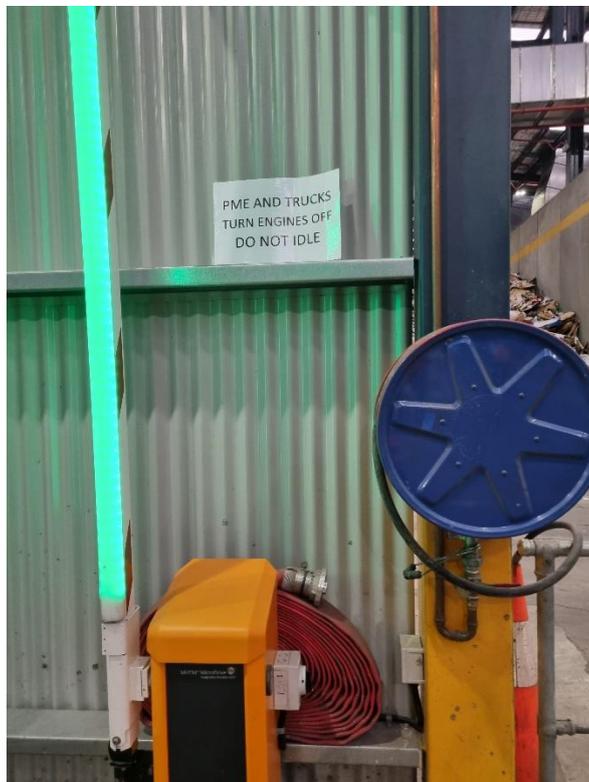
The facility was observed to operating in compliance with the requirements for the TMP except that signage directing engines to be turned off in the staging area was not in place. This was immediately corrected by the Site Manager who put signage in place within the designated staging area.

**Photo ID:** 6 - Signage directing engines to be turned off

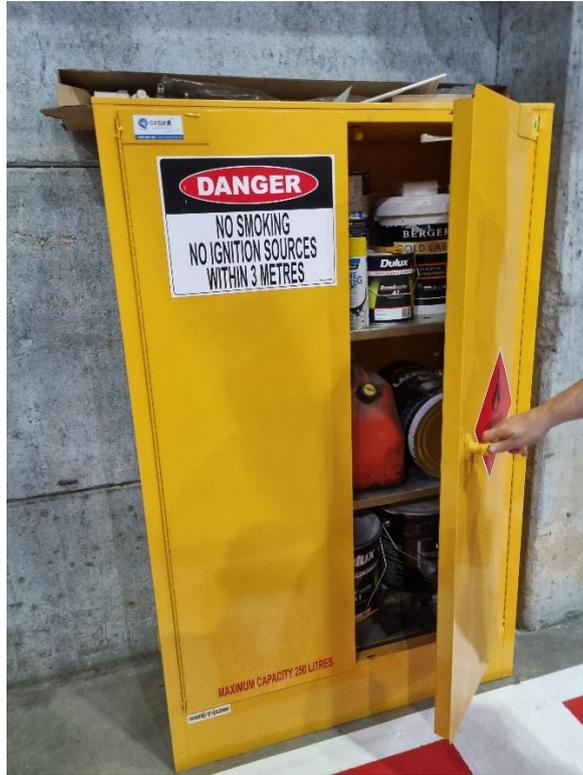
There is a flammable goods cabinet at the Site (see photo 7). The cabinet is used to contain small quantities of flammable goods. These includes small quantities of paint, petrol and similar products. No flammable goods were observed to be in storage outside of the cabinet during the Site inspection.

**Photo ID:** 7 – Flammable goods storage

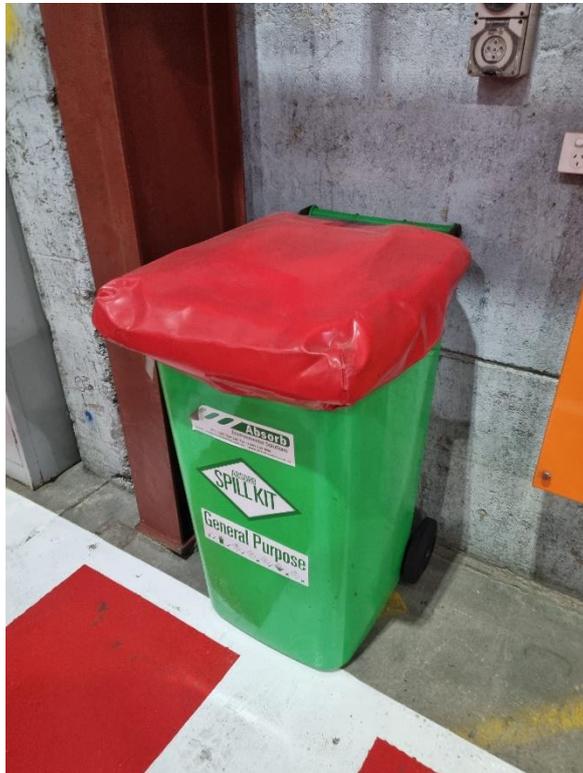
**Photo ID:** 8 – Spill kit

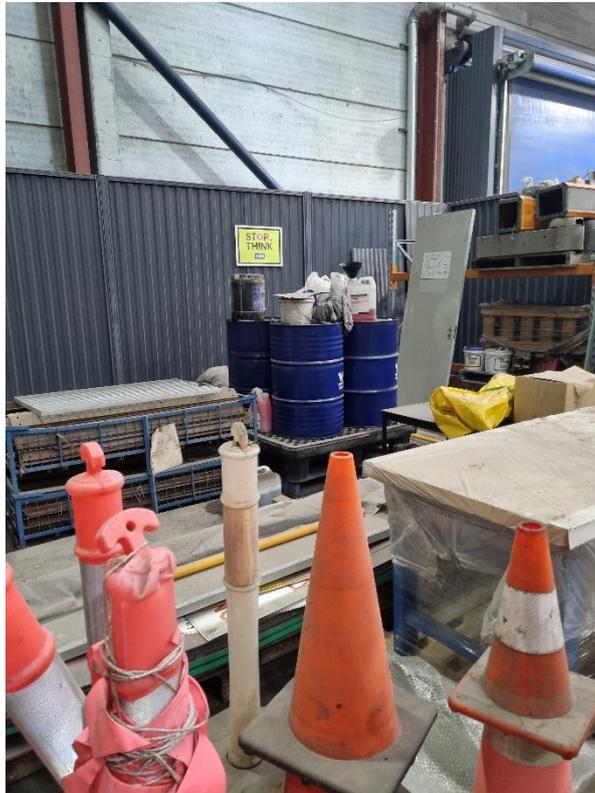
**Photo ID:** 9 – Hydraulic oil storage on banded pallet

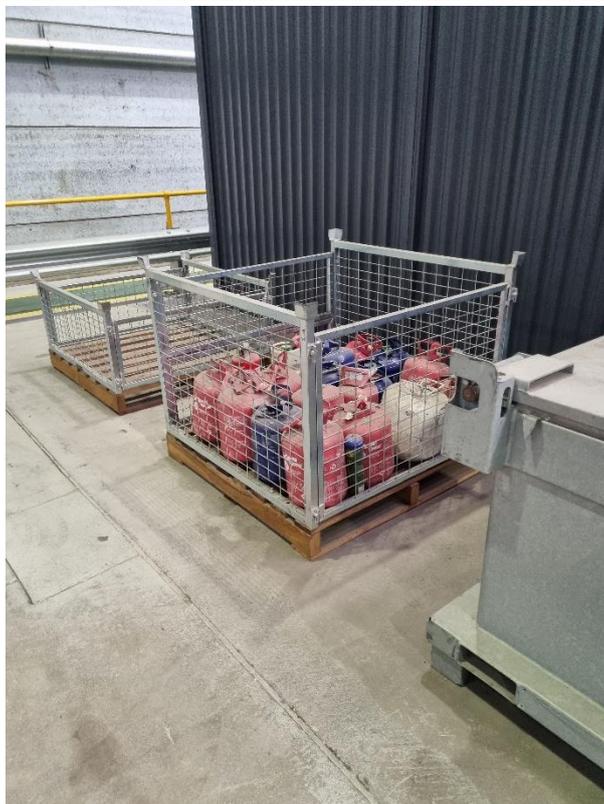
Dangerous goods are occasionally received as contaminants in waste. Examples of contaminant materials include gas bottles and car batteries. When found these are segregated in a dangerous goods area for appropriate disposal. Multiple secure storage containers are available to allow segregation of incompatible materials (see photos 10, 11).

**Photo ID:** 10 – Waste gas bottles storage

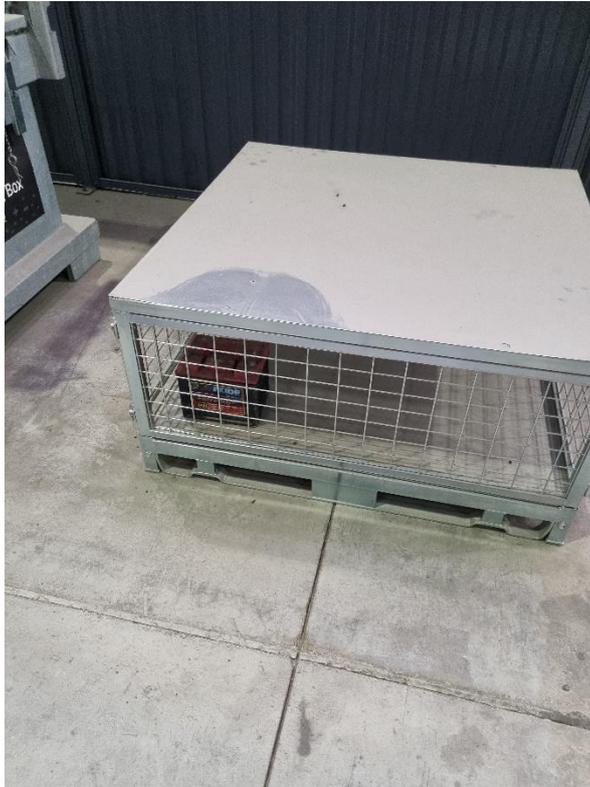
**Photo ID:** 11 – Waste car batteries storage

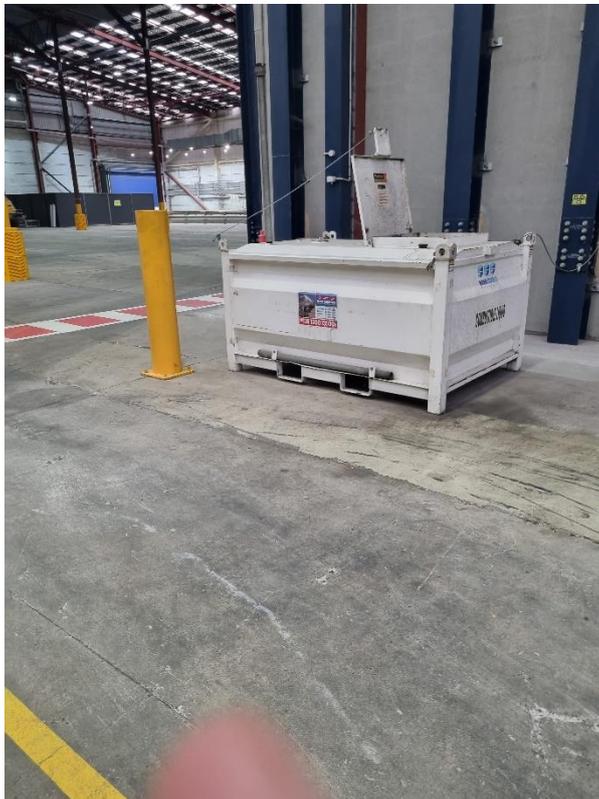
**Photo ID:** 12 – Diesel storage tank

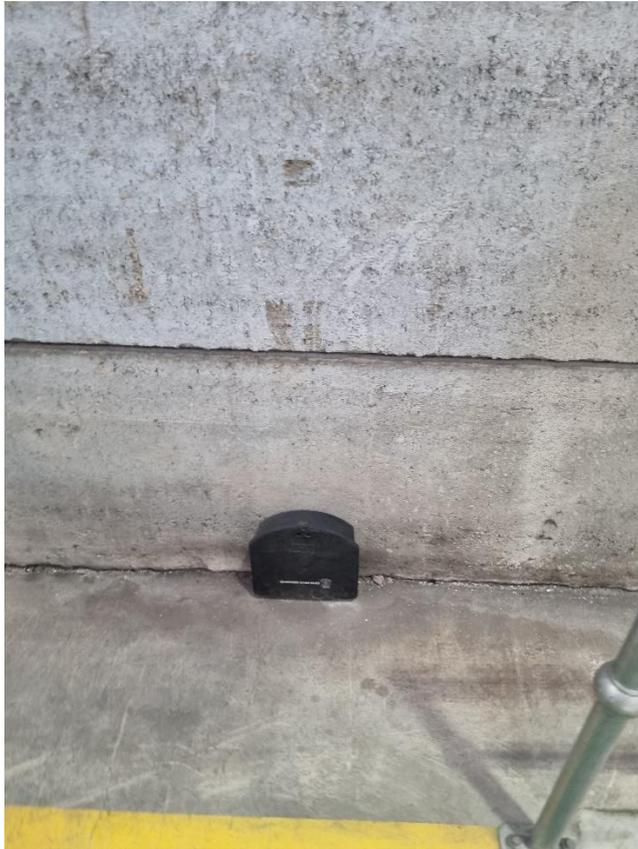
Pests, vermin and pests appeared to be properly managed and not expected to pose a hazard on the environment or cause any amenity issues.

**Photo ID:** 13 – Rodent bait trap
