VISY ALBURY

ENVIRONMENTAL MANAGEMENT REPORT

Compliance with EPA License 1272

1 July 2021 to 30 June 2022

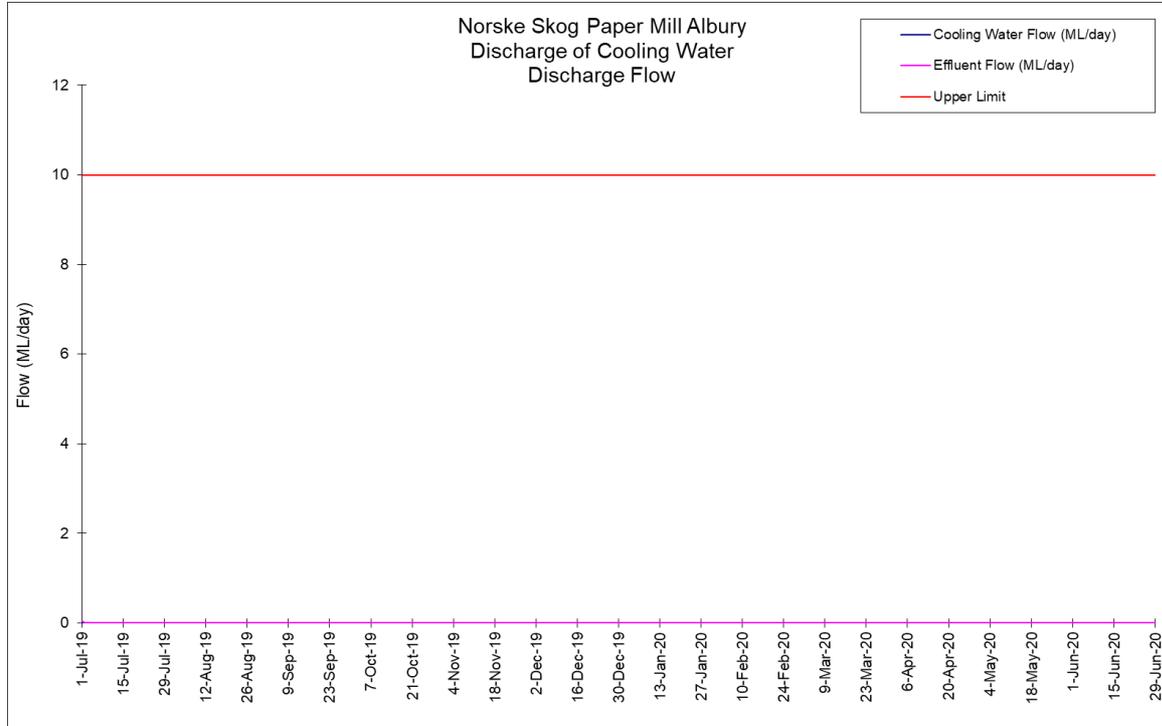
FIGURE 1. Over the 2020-2021 reporting period, Visy Albury did not release any treated effluent to the Murray River. Due to the idle state of the site river discharge was not required. Any cooling water and water that has entered the effluent system is being directed to the Ettamogah Dam.

Daily flows of treated effluent and cooling water discharged to the Murray River are presented in Figure 1 on page 16.

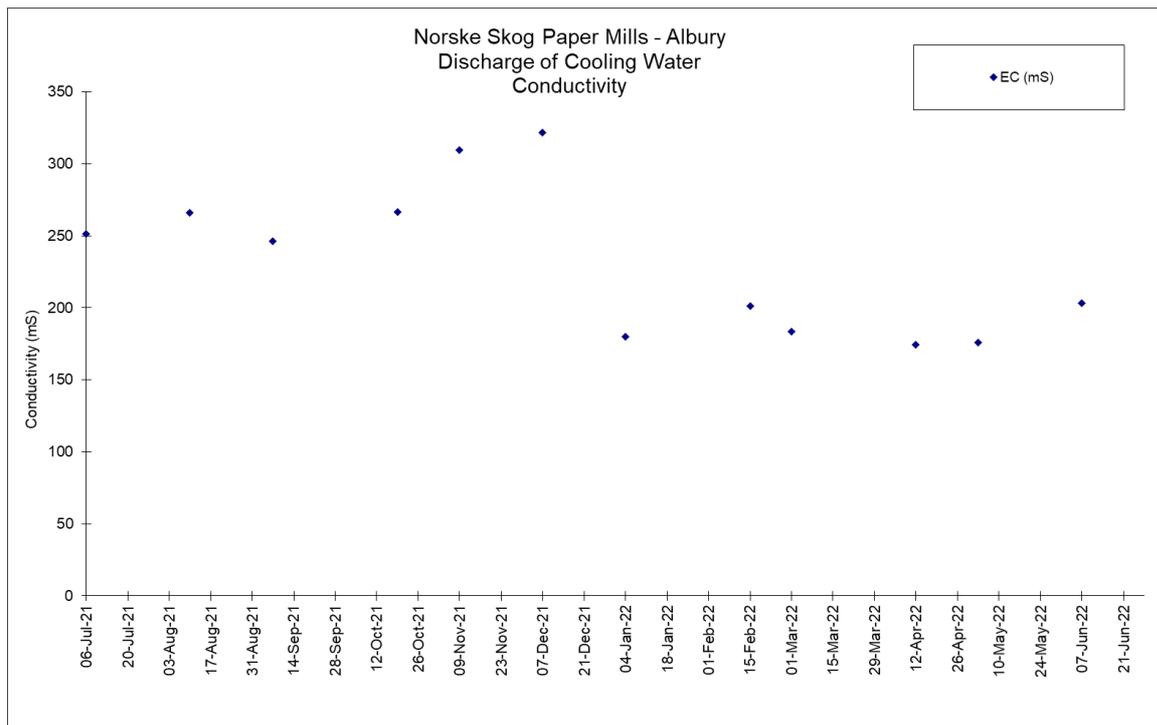
FIGURE 2. Conductivity of Cooling Water Discharged to Ettamogah Dam for irrigation

Cooling water continued to be monitored, even though none was discharged to the Murray River, with the results presented in Table 4 below. A graphical analysis is presented in Figures 2 to 5, with analysis and discussion to be found in section 3.3 on page 15.

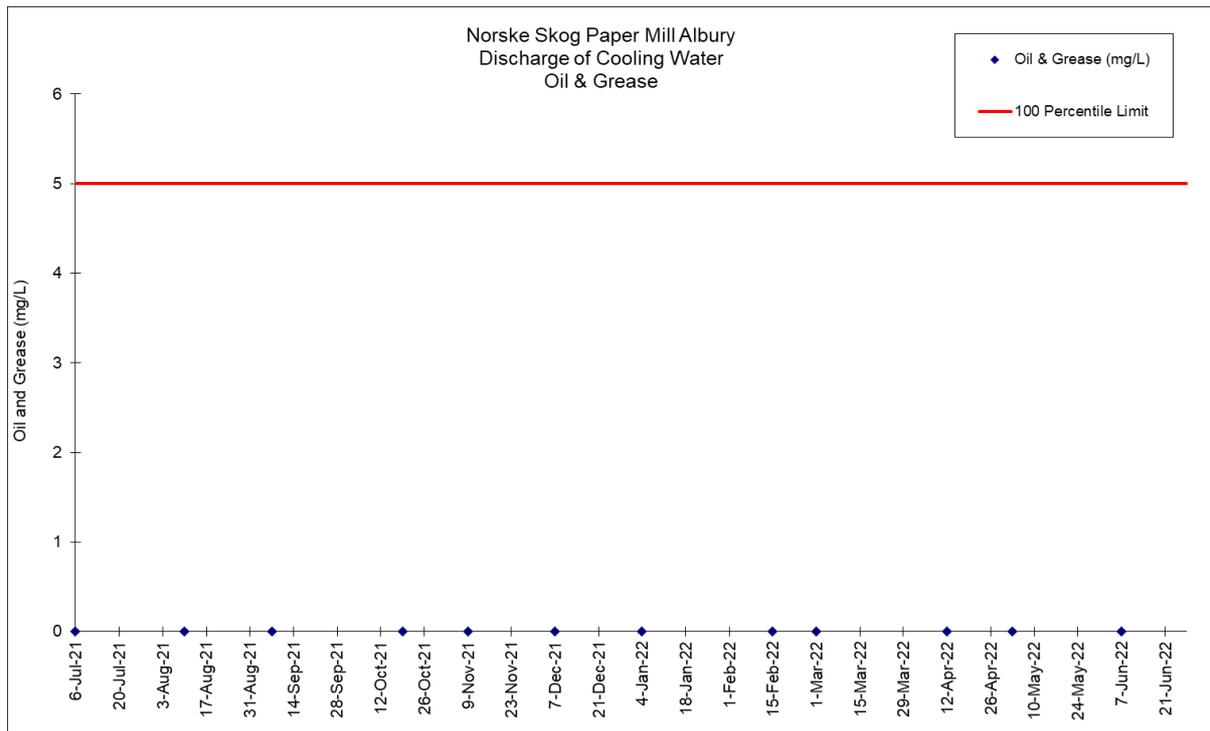
FIGURE 3. Oil & Grease of Cooling Water Discharged

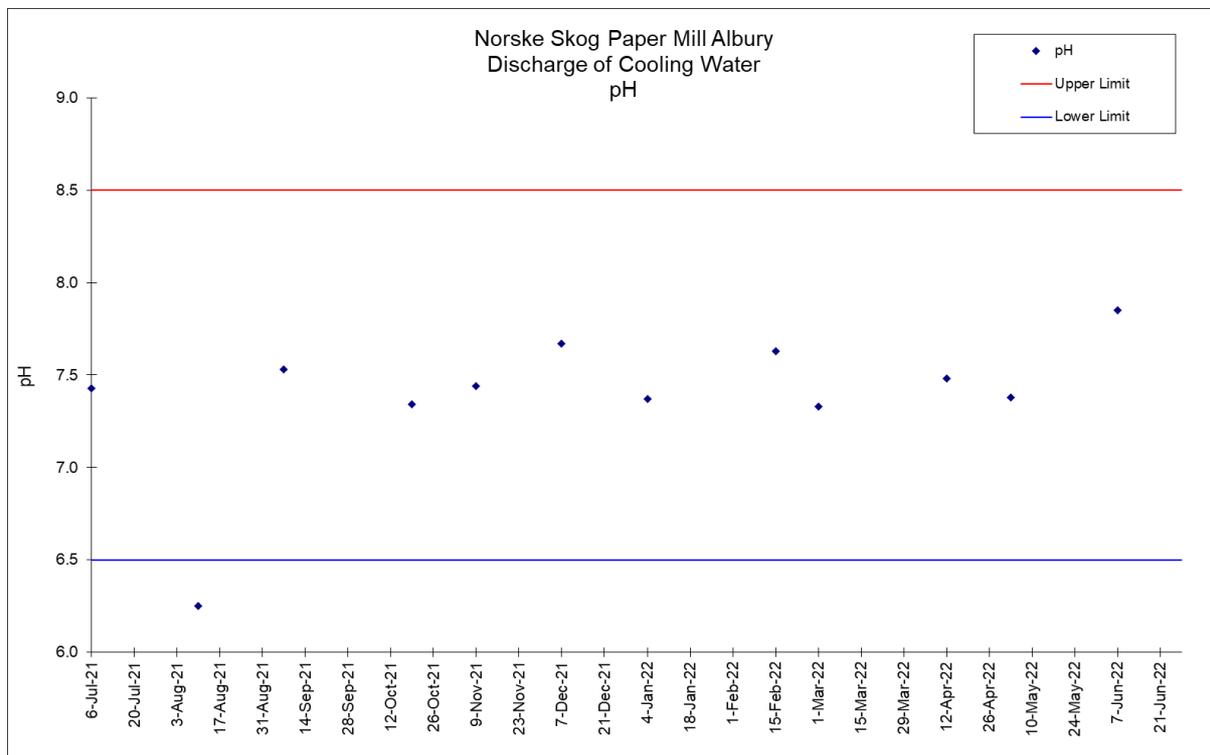
FIGURE 4. pH of Cooling Water Discharged

Throughout the 2021-2022 reporting period, all but one limit set for monitoring point 2 (cooling water) would have been met. All the results for pH were consistently around 7.5 (see Figure 4), except for an outlier of 6.3 measured in August. As the cooling water is currently not being discharged to the Murray River, a repeat test was not requested.

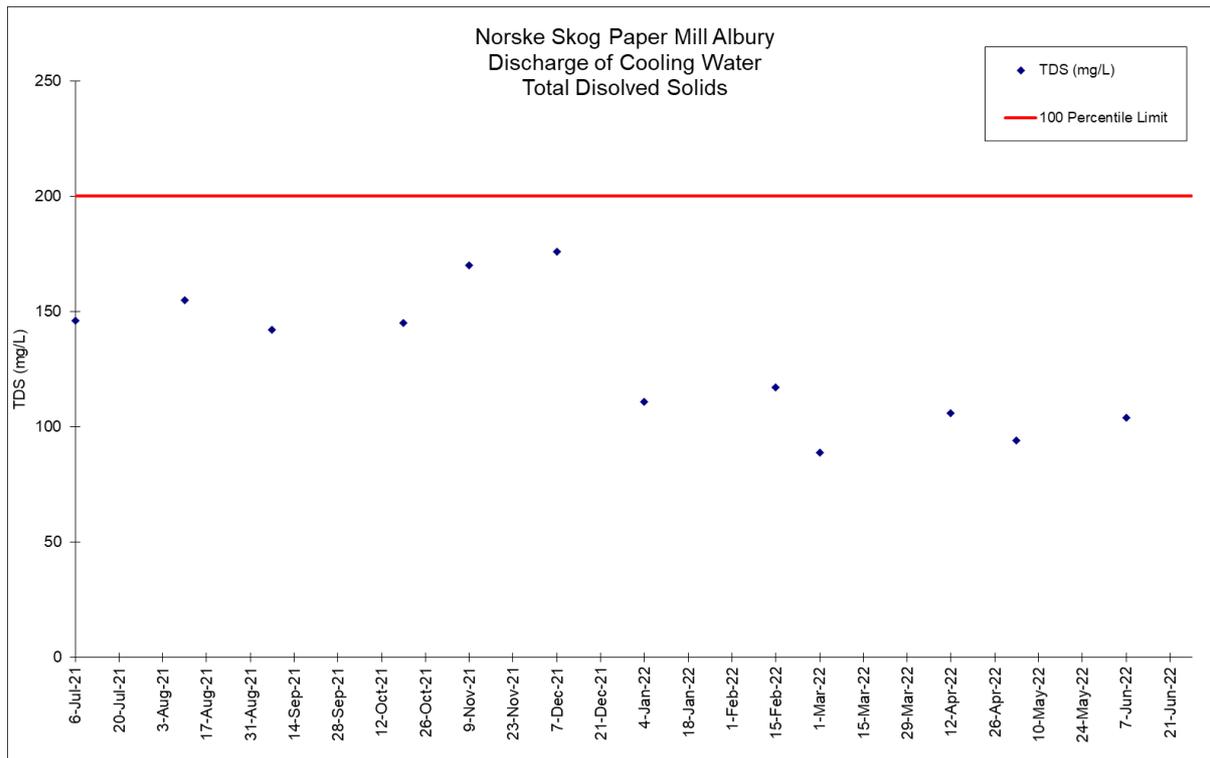
FIGURE 5. Total Dissolved Solids of Cooling Water Discharged

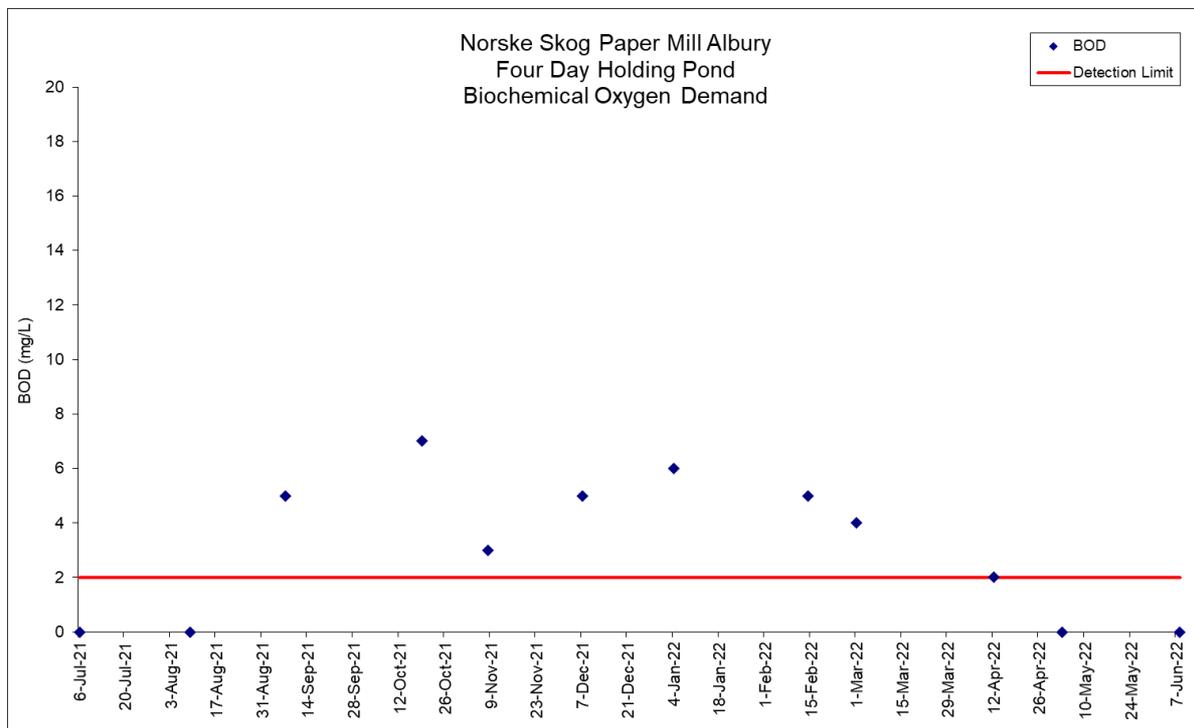
FIGURE 6. Biological Oxygen Demand of Treated Effluent from the Four Day Holding

Monitoring results of treated effluent quality from the Four Day Holding Pond are presented in Table 5 below, graphical analysis is presented in Figures 6 to 12 with analysis and discussion to be found in section 3.4, starting page 15.

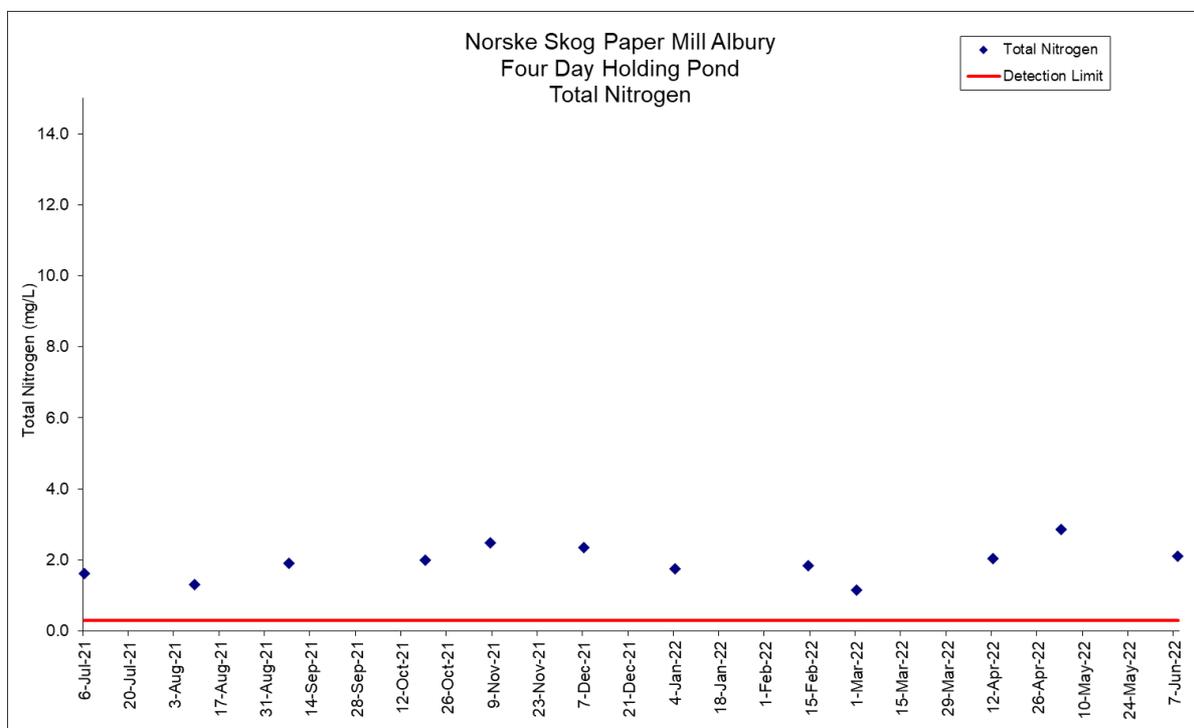
FIGURE 7. Total Nitrogen Concentration of Treated Effluent from the Four Day Holding Pond

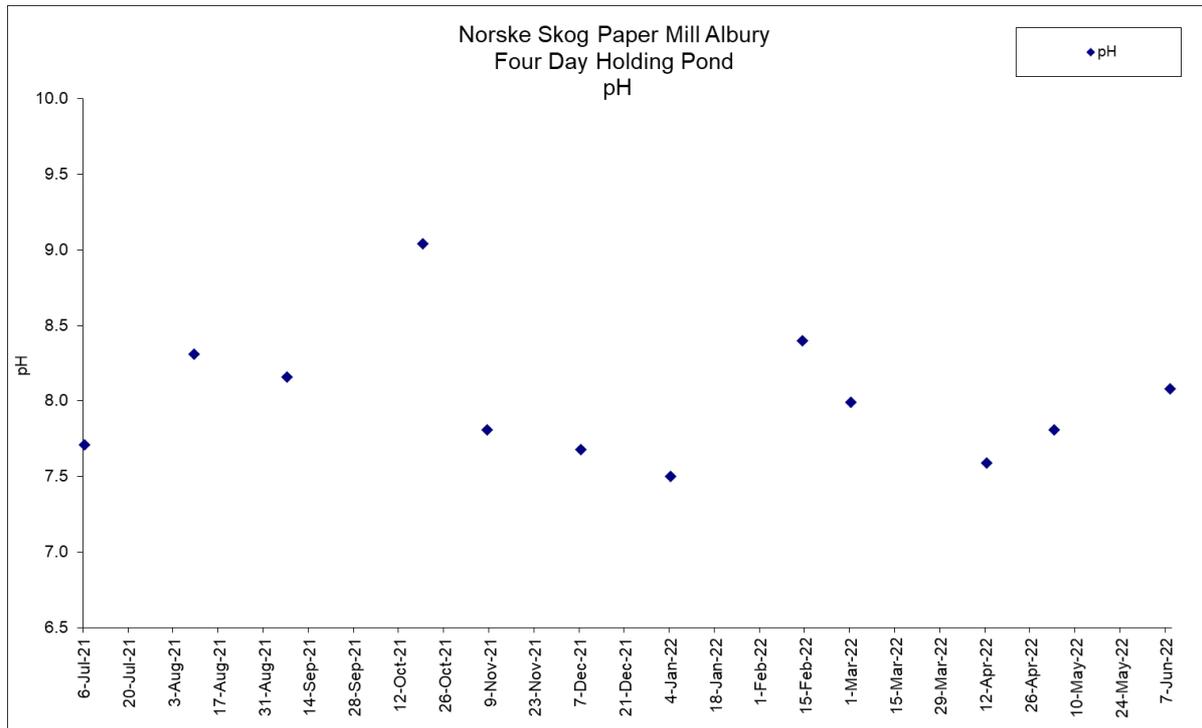
FIGURE 8. pH of Treated Effluent from the Four Day Holding Pond

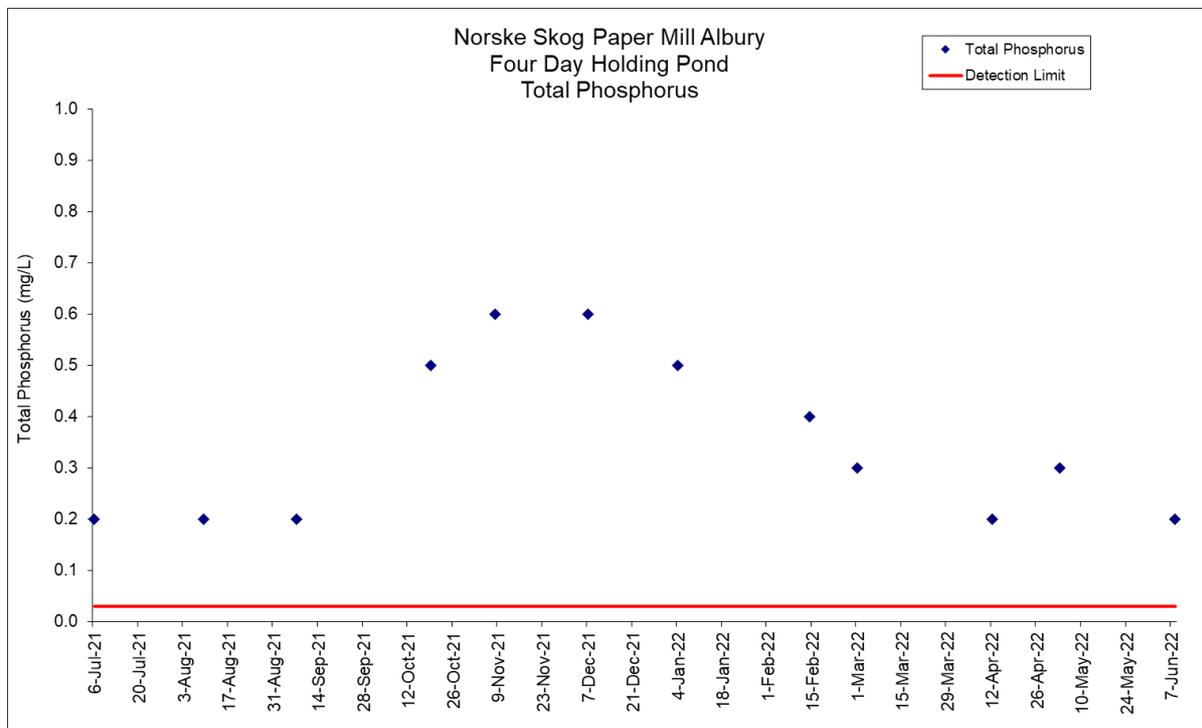
FIGURE 9. Total Phosphorus Concentration of Treated Effluent from the Four Day Holding Pond

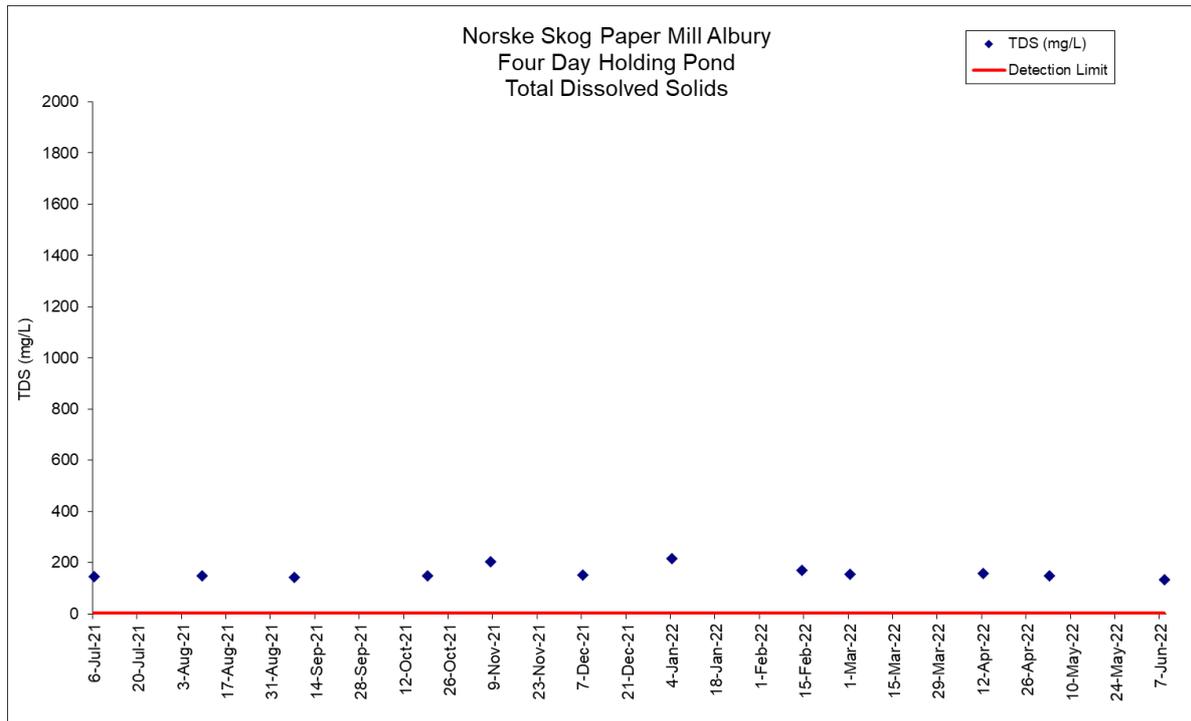
Figure 10. Total Dissolved Solids of Treated Effluent from the Four Day Holding Pond

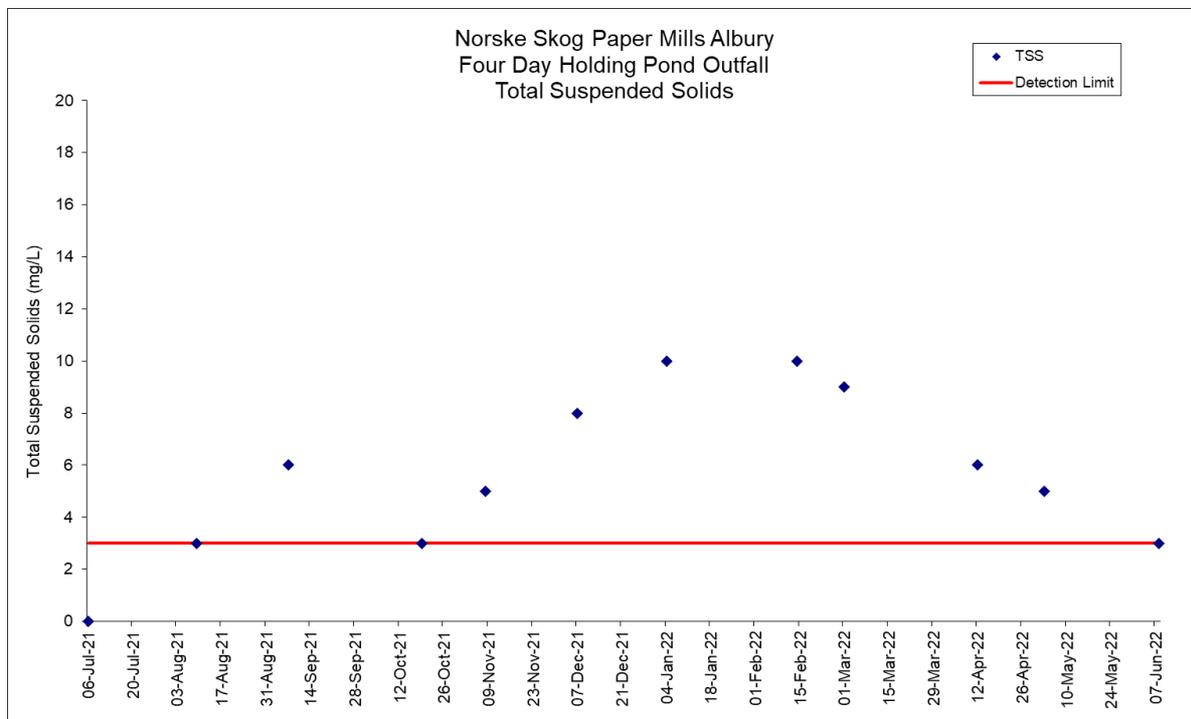
FIGURE 11. Total Suspended Solids of Treated Effluent from the Four Day Holding Pond

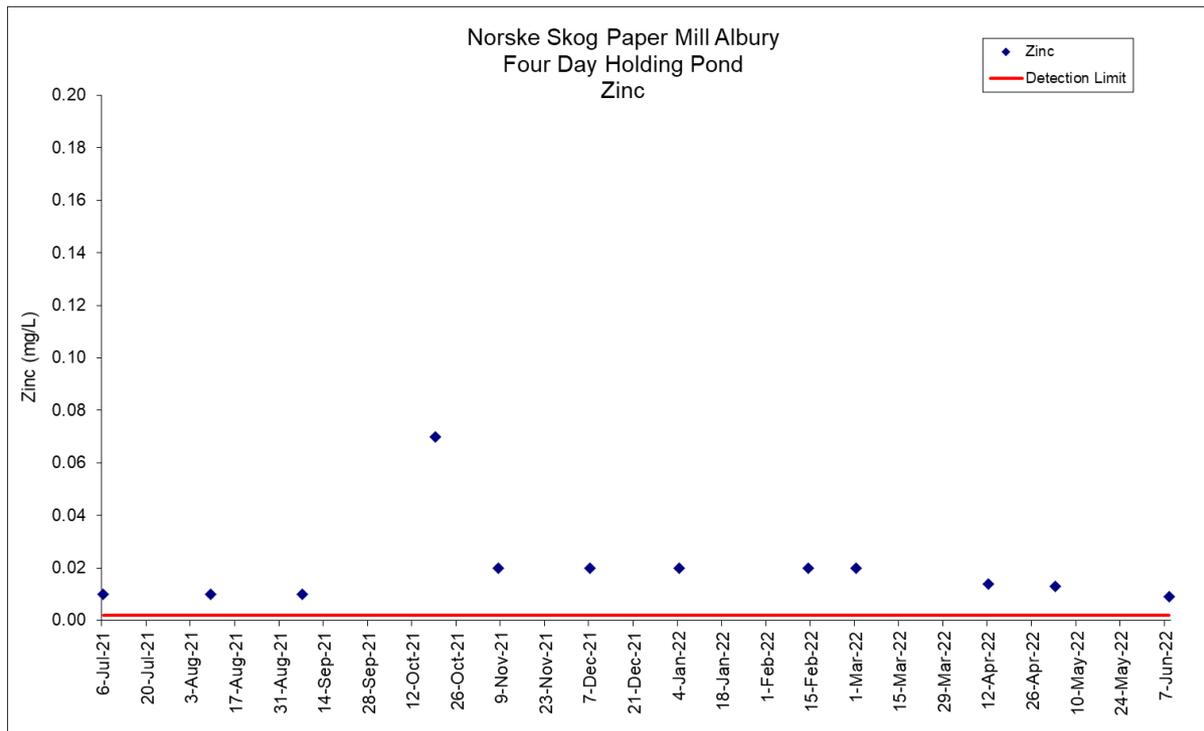
FIGURE 12. Zinc Concentration of Treated Effluent from the Four Day Holding Pond

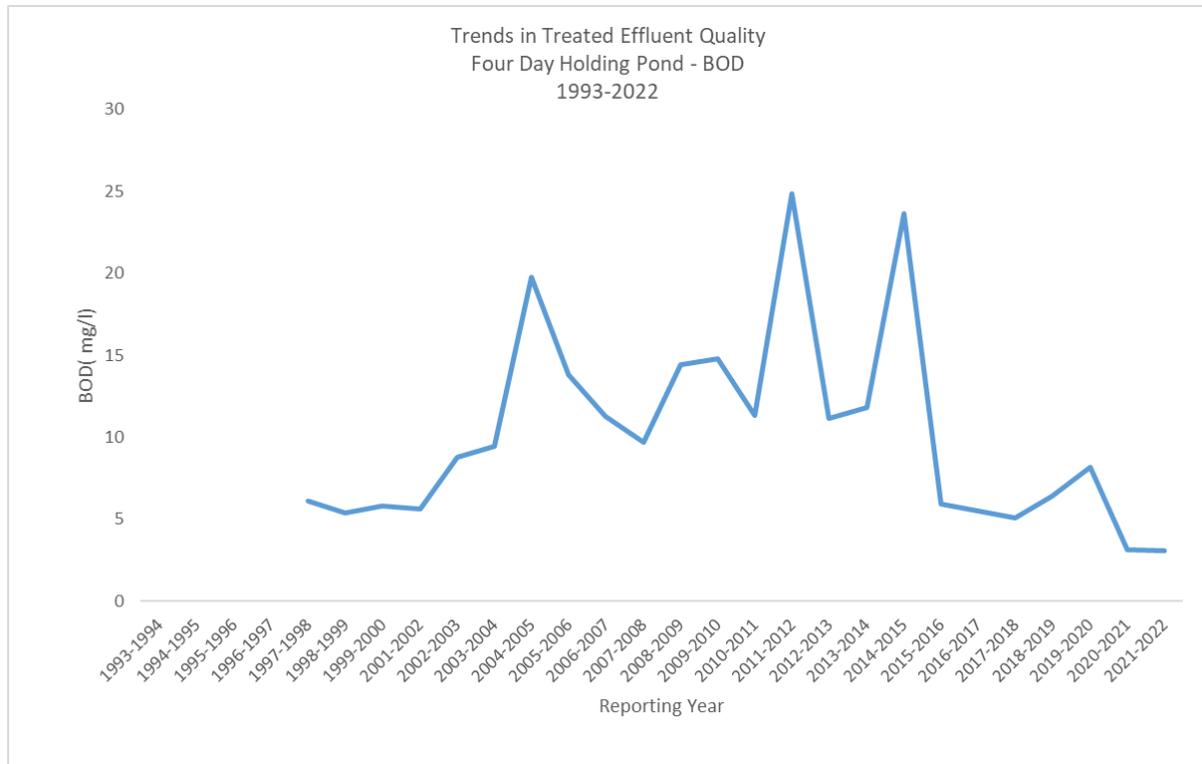
FIGURE 13. Trends in Treated Effluent Quality from the Four Day Holding Pond – BOD

Figures 13 to 19 present long-term data for treated effluent quality from the Four Day Holding Pond.

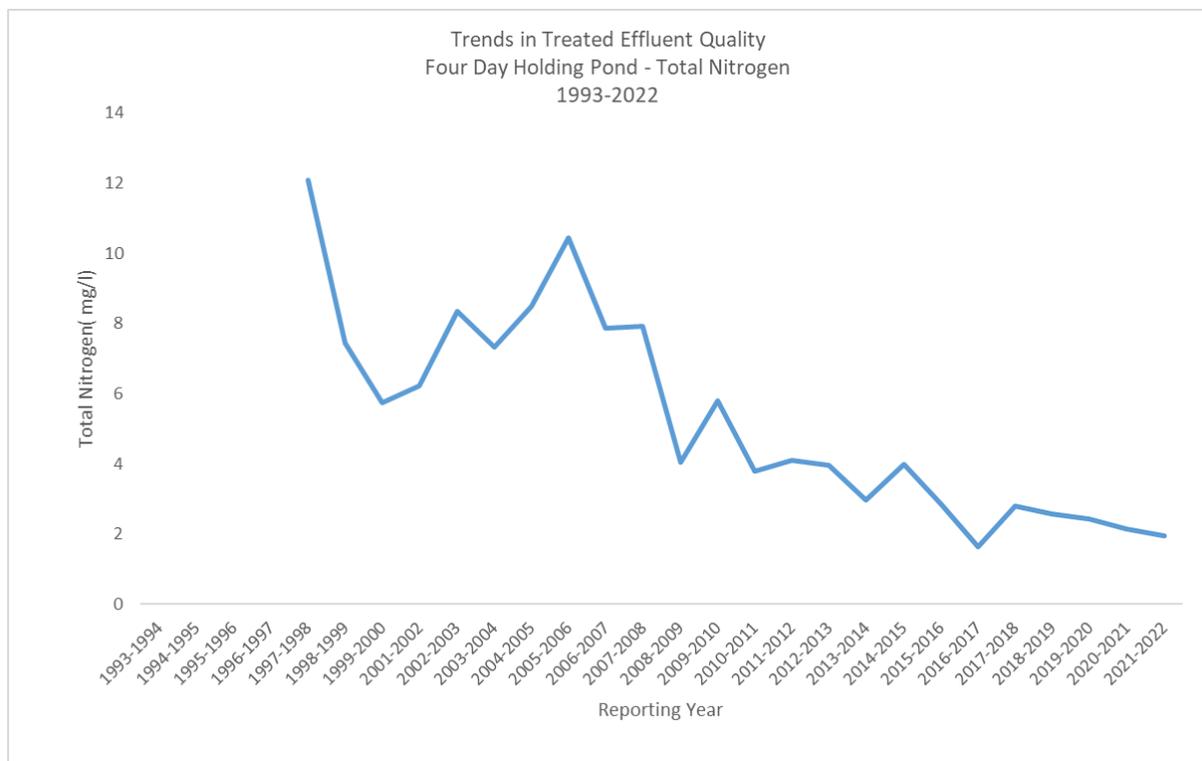
FIGURE 14. Trends in Treated Effluent Quality from the Four Day Holding Pond – Total Nitrogen

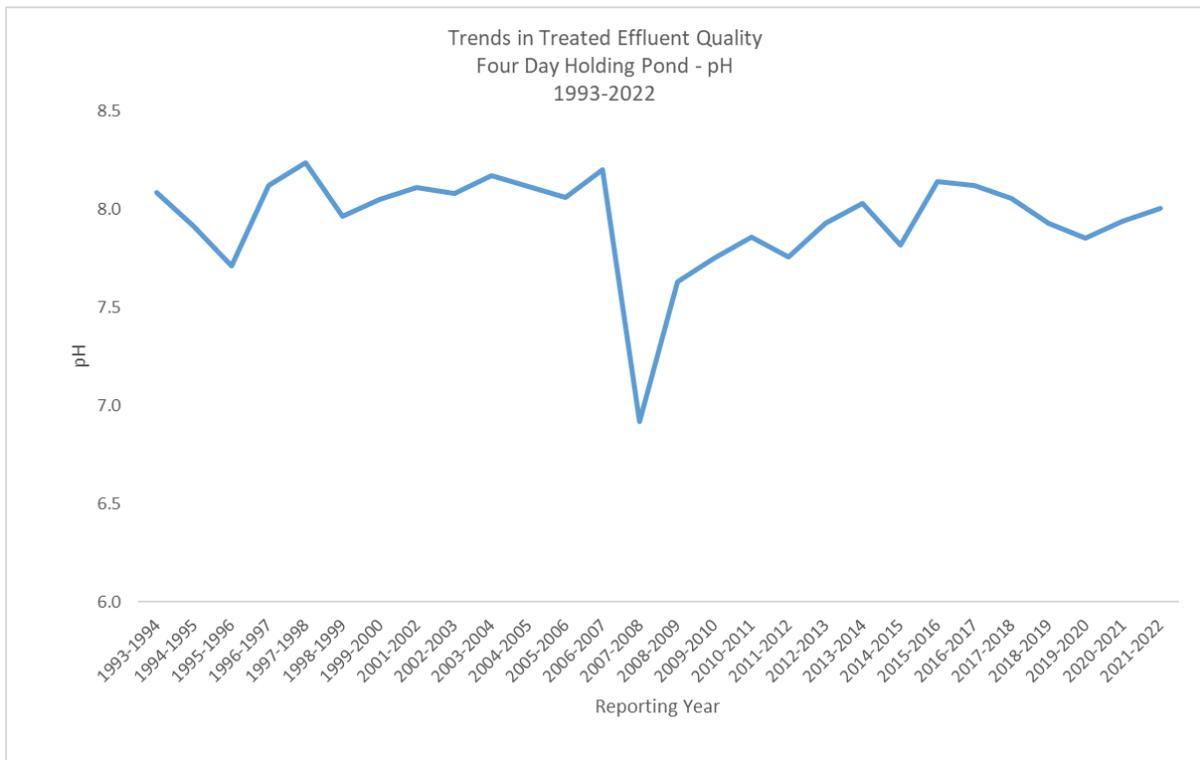
FIGURE 15. Trends in Treated Effluent Quality from the Four Day Holding Pond - pH

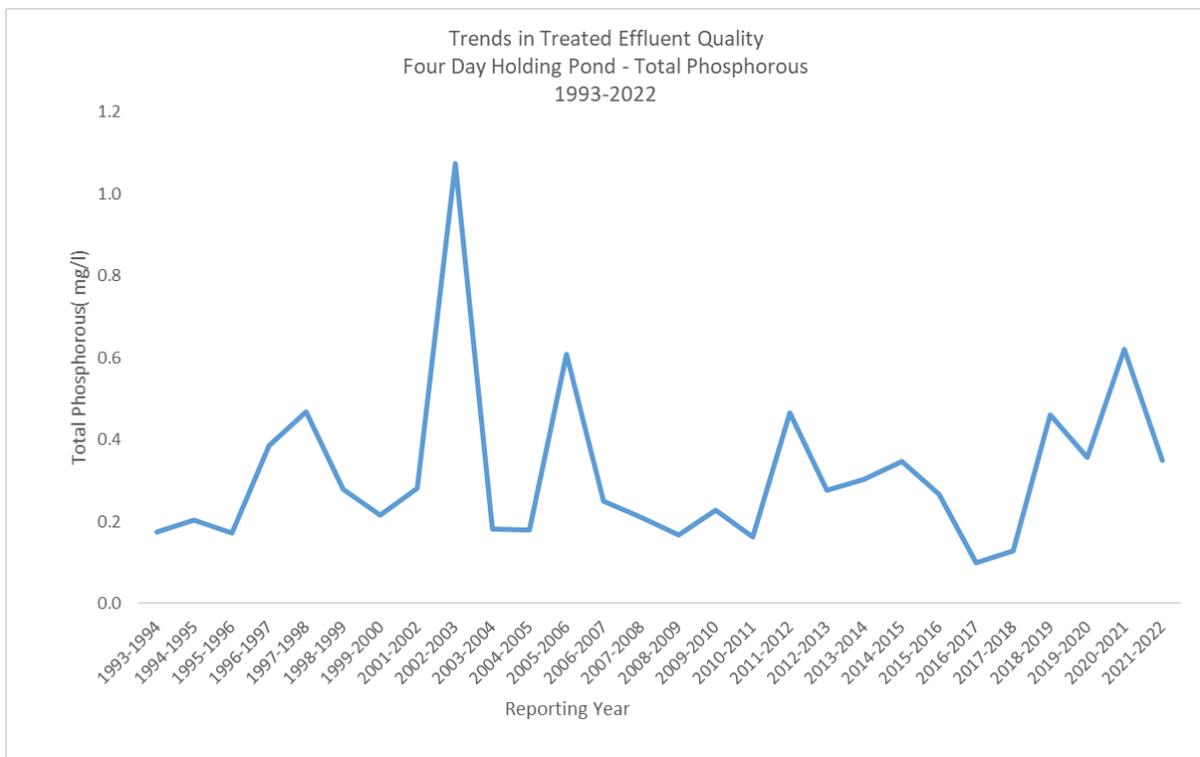
FIGURE 16. Trends in Treated Effluent Quality from the Four Day Holding Pond – Total Phosphorous

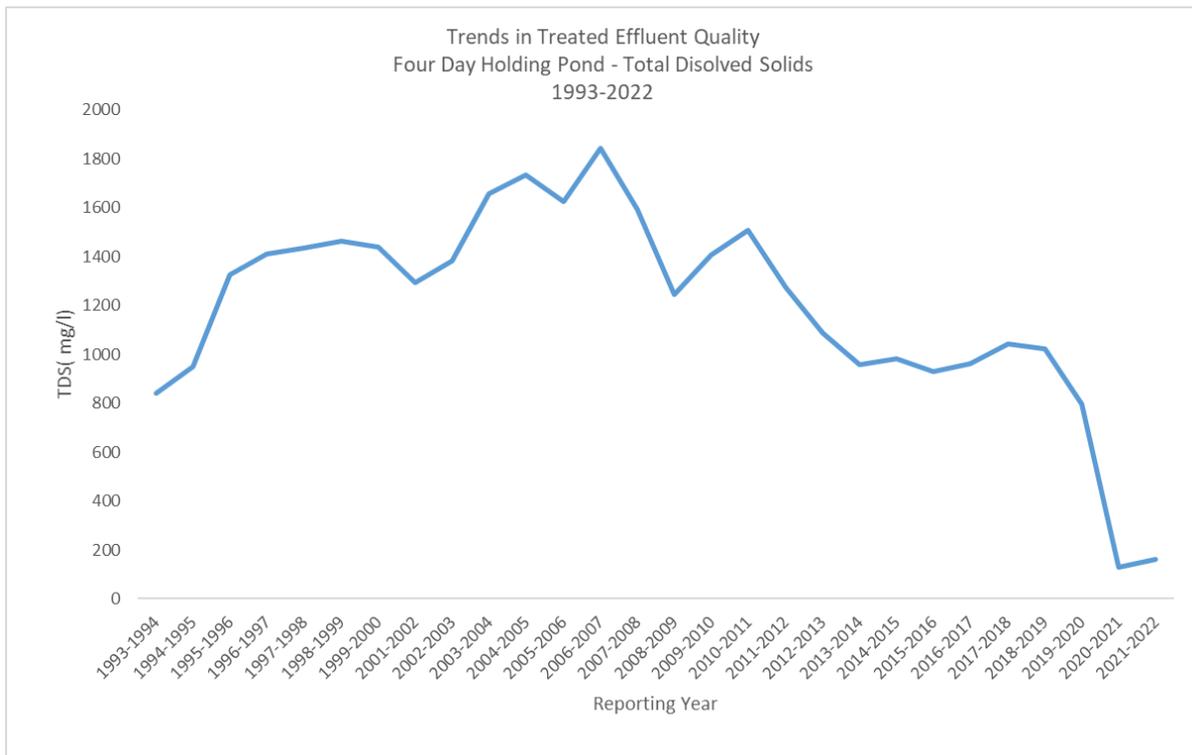
FIGURE 17. Trends in Treated Effluent Quality from the Four Day Holding Pond - TDS

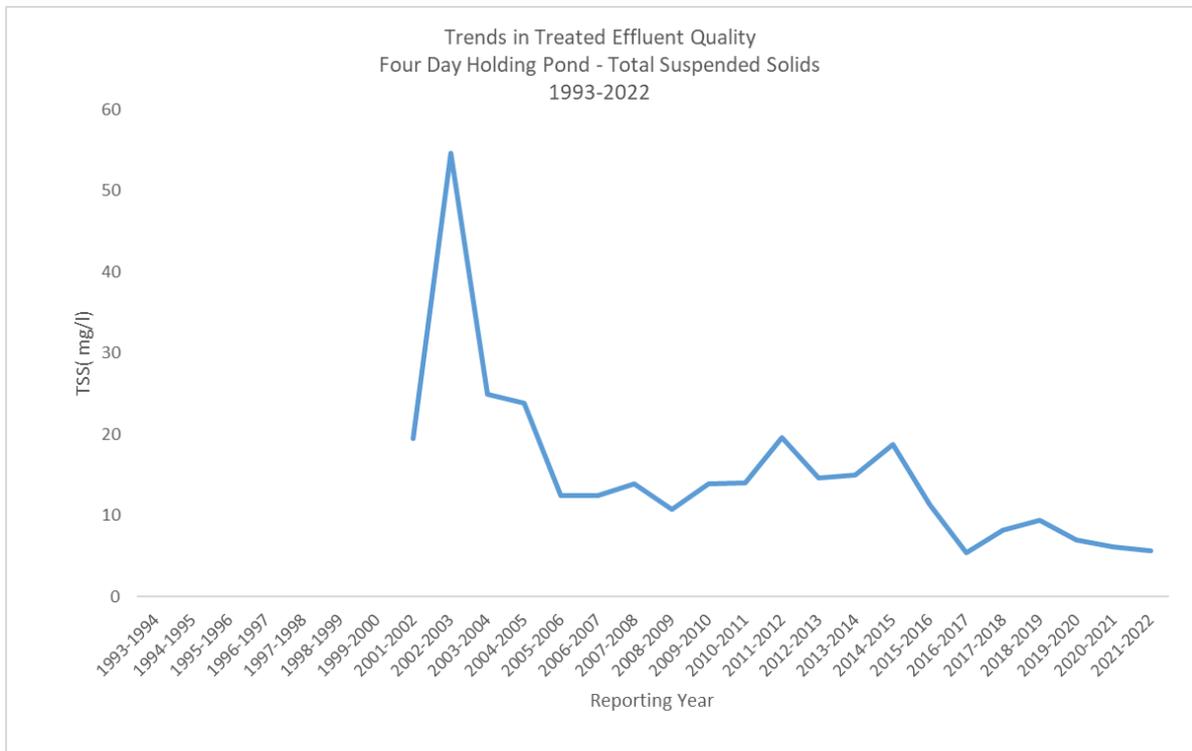
FIGURE 18. Trends in Treated Effluent Quality from the Four Day Holding Pond – TSS

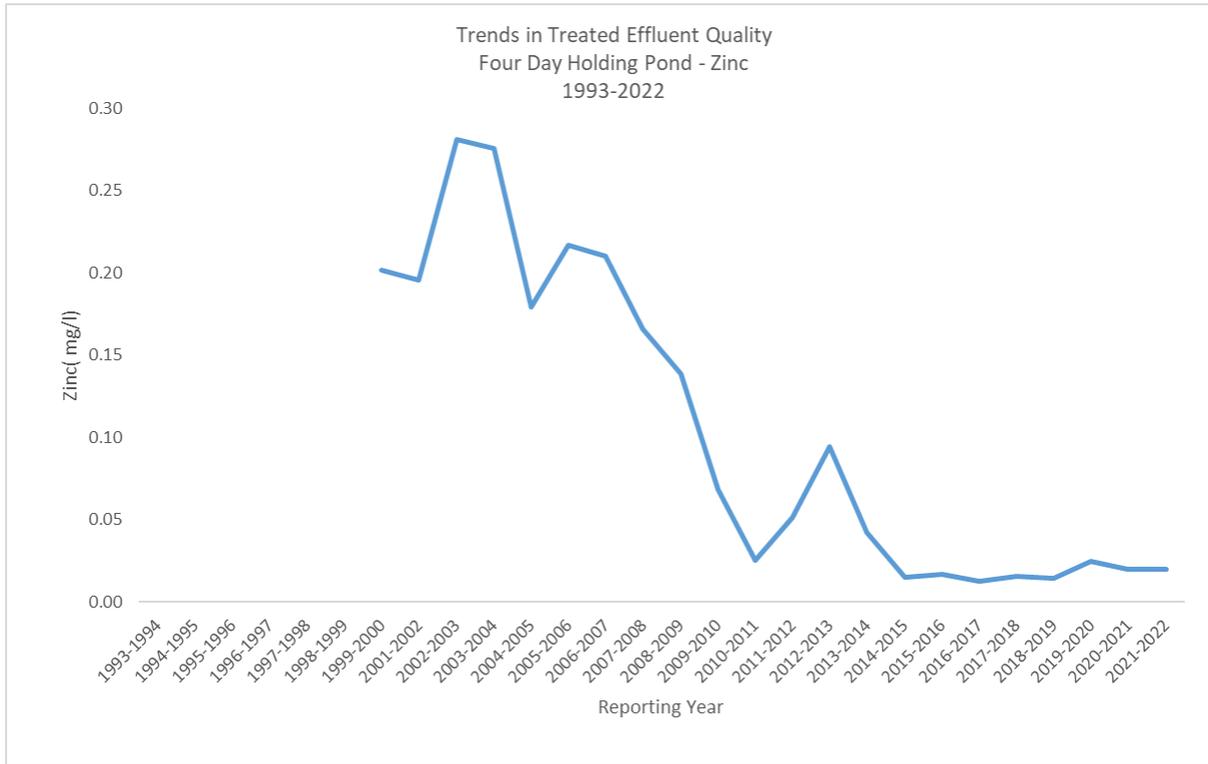
FIGURE 19. Trends in Treated Effluent Quality from the Four Day Holding Pond – Zinc

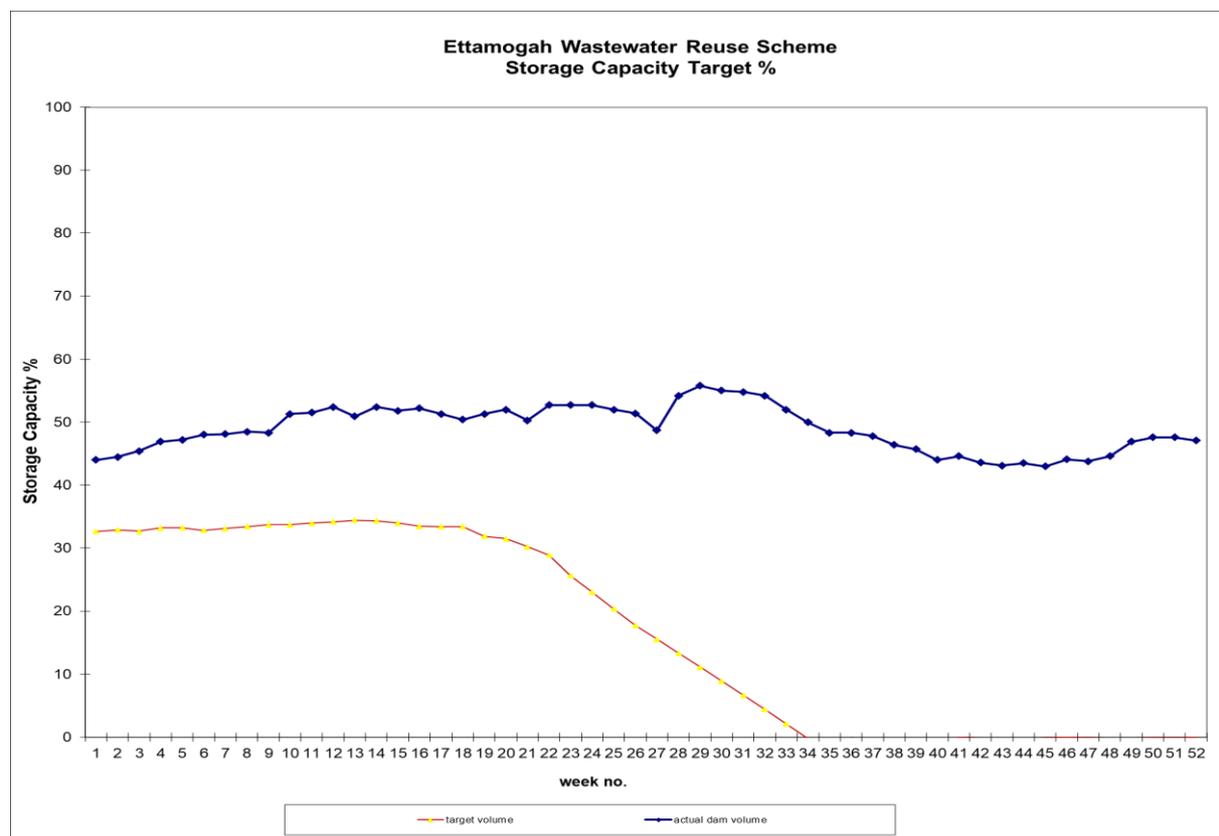
FIGURE 20. Winter Storage Dam Actual and Target Capacity

Throughout the most part of the 2021-2022 reporting period, dam volumes were well above the target levels set by the Irrigation Area Management Plan. This is because of the above average rainfall, which could not be predicted when the Irrigation Area Management Plan was developed. Since the Mill has been non-operational an increased volume of water in the dam has been preserved. This will be available for the irrigation seasons over the next couple of years while the mill is in an idle state.
