Visy Pulp & Paper Tumut Mill

Environmental Compliance and Monitoring Report 2023

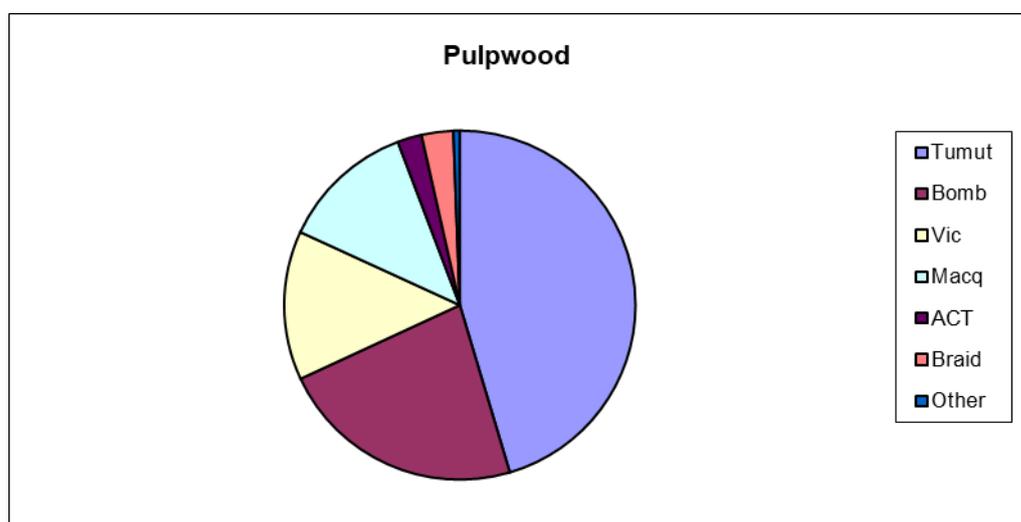
Figure 2: Pulpwood supply by region for 2022 – 2023

Figures 2 and 3 below show the raw material supply by region

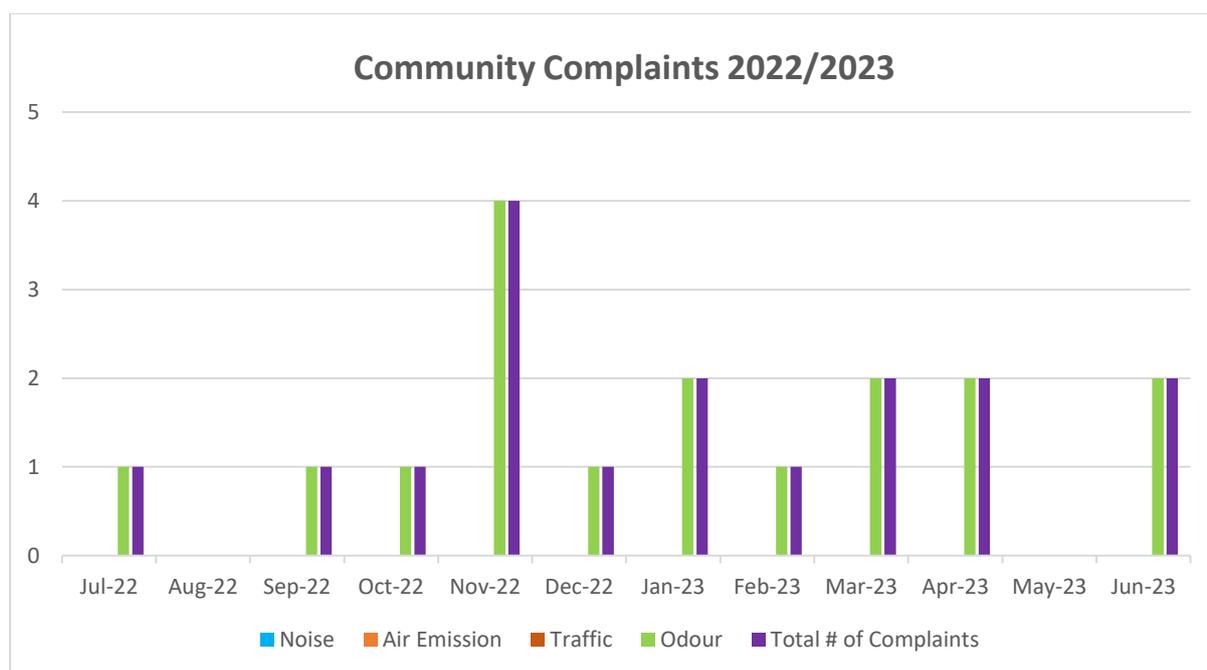
Figure 4: Community complaints for 2022 – 2023

The total complaints received during the reporting period have been tabulated and are presented below, Figure 4. Comparisons with historical monthly complaints are illustrated in Table 5.

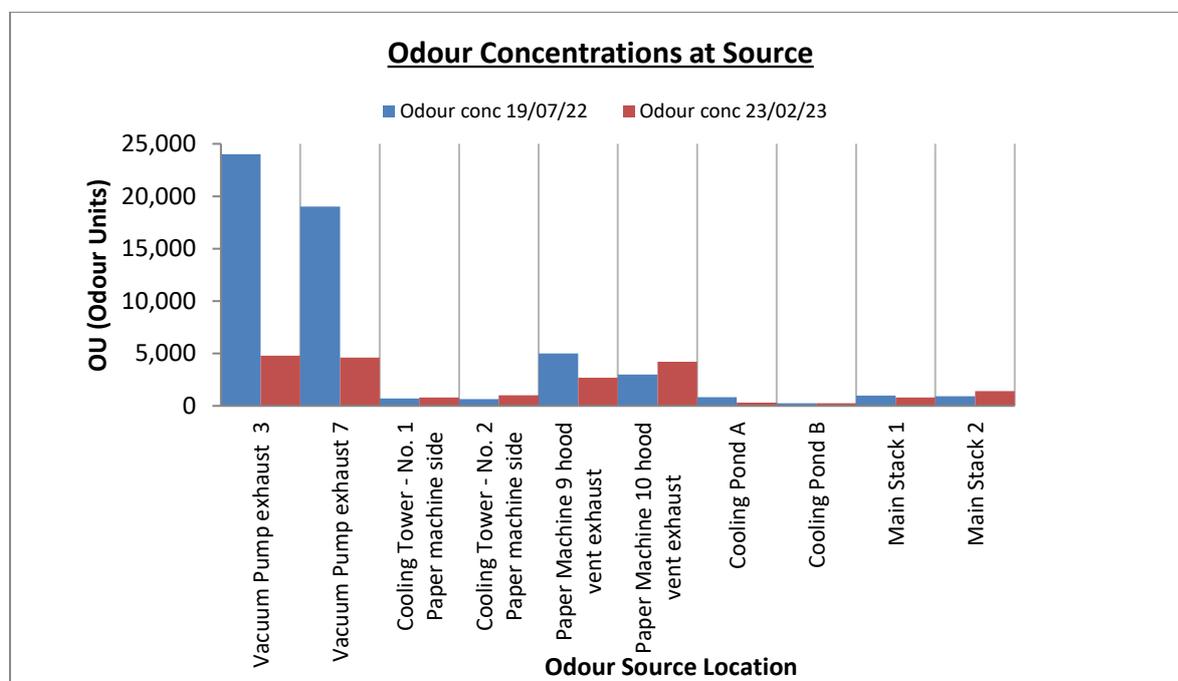
Figure 5: Odour concentrations at source

The odour concentrations at each source and sampling date are shown below in Figure 5.

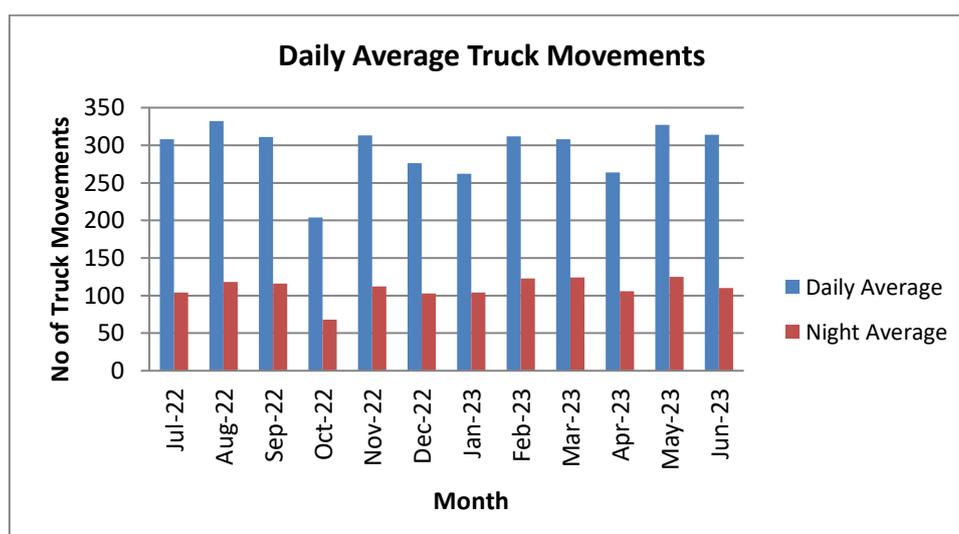
Figure 6: Daily average truck movements

As predicted in the EA and the Traffic Management Plan there is a greater number (75%) of truck movements during the daytime period (7am to 10pm) compared to the night period. The main heavy vehicle nighttime movements from 10pm to 7am are due to pulp log, sawmill chip and finished paper.

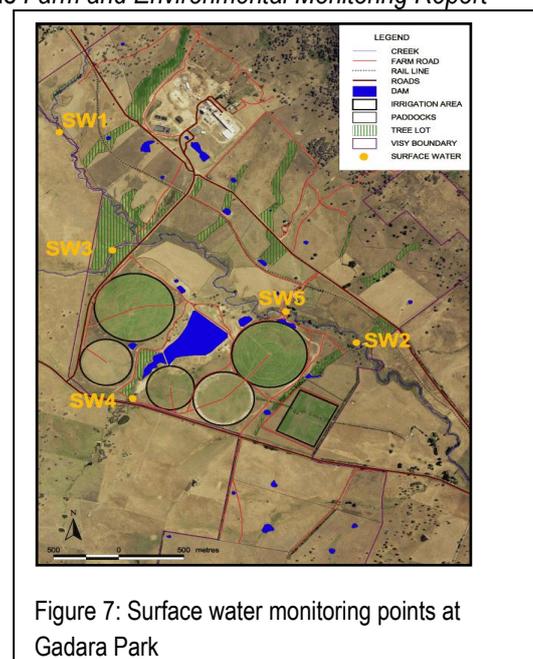
Figure 7: Surface water monitoring points at Gadara Park

The surface water monitoring sites can be observed in the following map of the Visy Mill and Gadara Park farm site are shown in Figure 7. Three of the monitoring sites are upstream (SW1, SW3 and SW4) of all mill and irrigation activities and the other two sites are downstream (SW2 and SW5).

The monitoring results from sites upstream of the mill are compared with those downstream to determine if the mill and irrigation activities are having an effect on water quality.
